EOS in Lausanne, Switzerland reports good results with FILARC PZ6166 metal-cored wire in rebuilding Pelton wheels

By J. Sauberlin, Technique de Soudage et Essais Métallurgiques SA, Ecoteaux, Switzerland, and K. Blome & B. Altemihl, FILARC Welding Industries B. V., Utrecht, The Netherlands

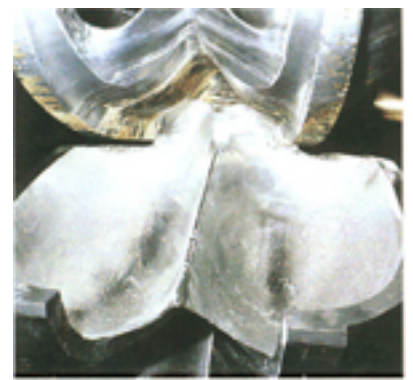
Figure 3 shows a worn bucket. The characteristic wear pattern is ground level prior to welding.

Figure 3. Pelton wheel buckets with characteristic wear pattern.

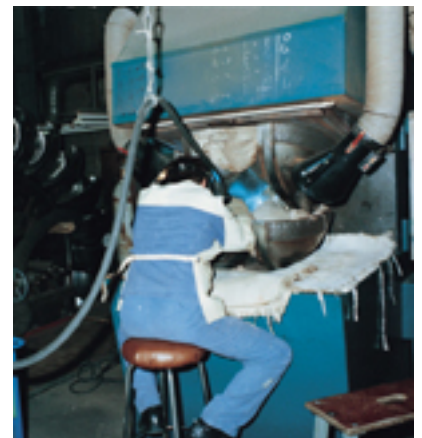
Figure 4 gives the situation during repair welding. The Pelton wheel is surrounded by a specially designed oven and kept continu-

Figure 4. Overview of workshop arrangement for reconditioning

ously at a preheat temperature of 120°C. After rebuilding, the wheel is tempered at 590°C in another oven.

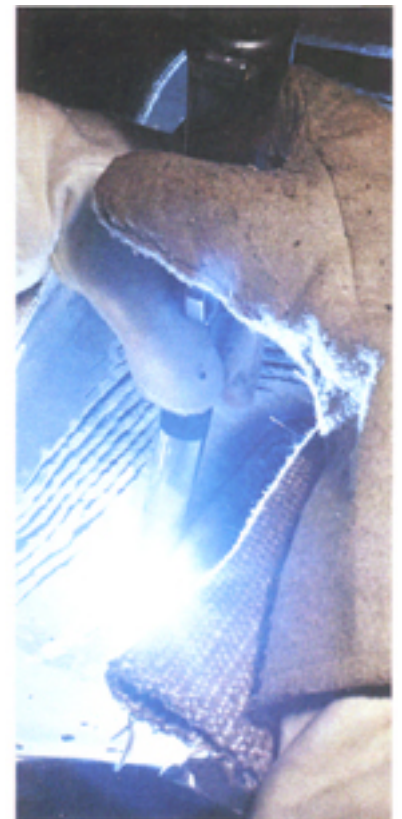
Figure 5. Ergonomic conditions are far from ideal.

The conditions under which the welders work are far from ideal. The accessibility of the workpiece is very limited and further hindered by pieces of wood and blankets used to protect them from

the heat. Often forced to hold torches in an unnatural way, welders make the complex circular movement needed to rebuild the worn surfaces in predominantly the 2G and 3G positions (figure 5). Most importantly, they must ensure good penetration at the toes of previous beads, and avoid undercut to prevent lack

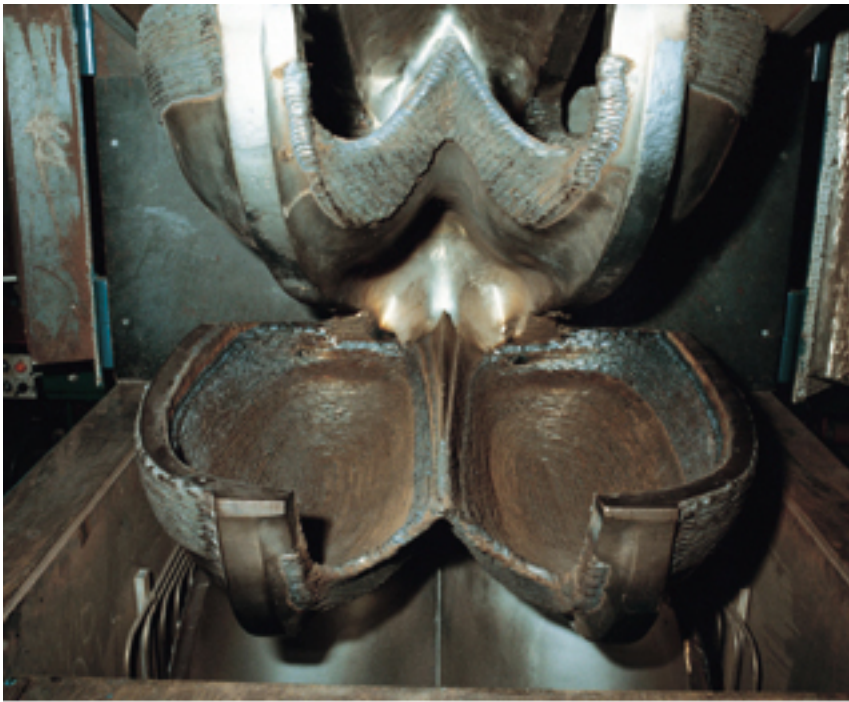
Figure 6. Pelton wheel buckets after rebuilding with PZ6166

Figure 6 shows a bucket that has been rebuilt with FILARC PZ6166. The cored wire is used to repair worn areas at both the inside and the outside of the bucket (3G position). GTAW is still applied to rebuild the root of the buckets. Here superior toughness is needed because of the high dynamic loading.

Two other advantages over solid wire GMAW become apparent when equalising the rebuilt surface of the buckets by grinding and polishing. Welds are on the one hand flat and well washed, and on the other hand show no undercut at the toes of the beads. This leads to considerably less grinding and repair welding than needed with solid wire, shortening the total time of reconditioning the wheels; so contributing to more efficient repair.
