Repair welding of blades for rubber mixing

by Roland Bürgel, Dienst-Apparatetechnik GmbH + Co. KG, Siegen and Rolf Paschold, ESAB GmbH Solingen

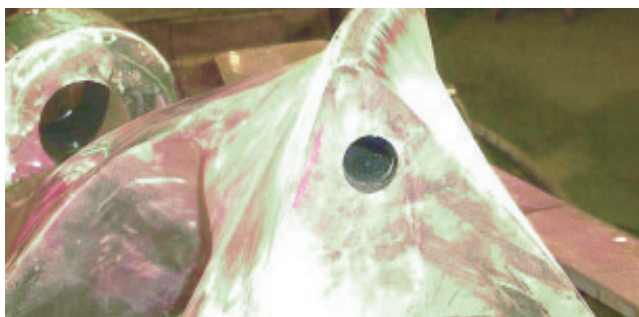
Fig. 1. First build-up layer welded on the mixer blade with OK Tubrod 15.34.

Dienst-Apparatetechnik and ESAB preferred a different weld metal. To ensure that the weld metal did not separate from the base metal, it was decided to begin by applying a tough, strong buffer layer before hardfacing. For this reason, **OK Tubrod 15.34** was used to weld the buffer layer on the machined edge of the mixer blade (Fig. 1) and, for the hardfacing layers, **OK Tubrodur 15.81** was chosen, giving a martensitic weld metal including fine-grained, dispersed carbides (Fig. 2). This is important when it comes to creating very high wear resistance to fine-grained abrasives causing erosion. OK Tubrodur 15.81 is also suitable for abrasion from fine-grained materials combined with high pressure or a medium impact load. If a weld metal with large grained chromium carbides in a ledeburitic matrix is used, the matrix between the carbides wears out before the carbide itself. This is avoided by using OK Tubrodur 15.81.

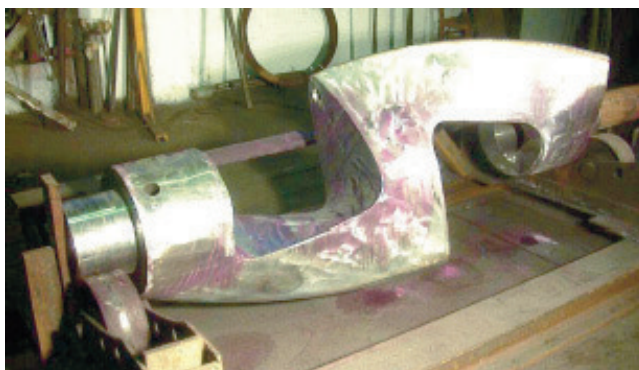
Fig. 2. Repair welded mixer blade ready for profiling by grinding.

After more than a year in operation, the repaired mixer blades display no significant wear or damage. The owner of the mixer is very satisfied and approved both flux-cored wires and the welding procedure for this application.
